Manhole Inspection Summary

Manhole # S37EE_030MH

Insp Date: **6/30/08 10:17 AM**

Location Address: **1103 BRENTWOOD AVE**

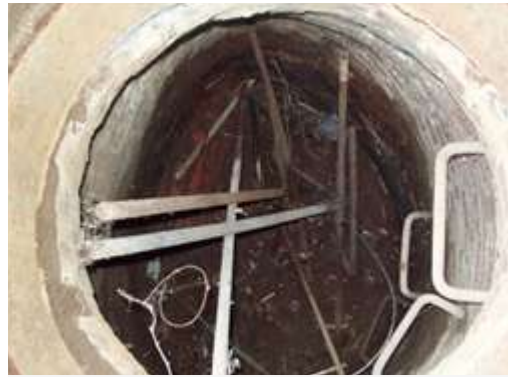
Top View

Barrel infiltration. Channel debris.

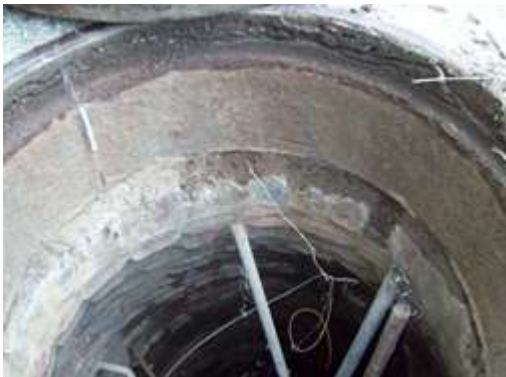
Defect

Frame leaks. Frame offset. Adjustment deterioration and infiltration. Corbel and Barrel infiltration.

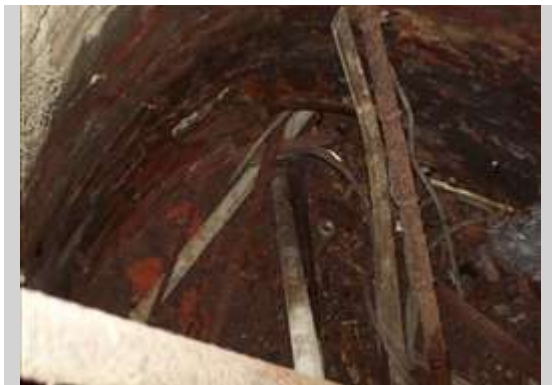
Pipe Out @ 12 O'Clock

The pipe is full of debris.

Deposits: ☐ None ☒ **Mud** ☐ Sludge ☒ **Debris** ☐ Grease

Silt Depth: **8** (in.)

Deposits Extent: **Heavy**

Rod and Bar (Angled)
